Rebuilding the bandswitch on a Kenwood Hybrid radio – TS-530S and TS-830S

Dick Housden – W0NTA

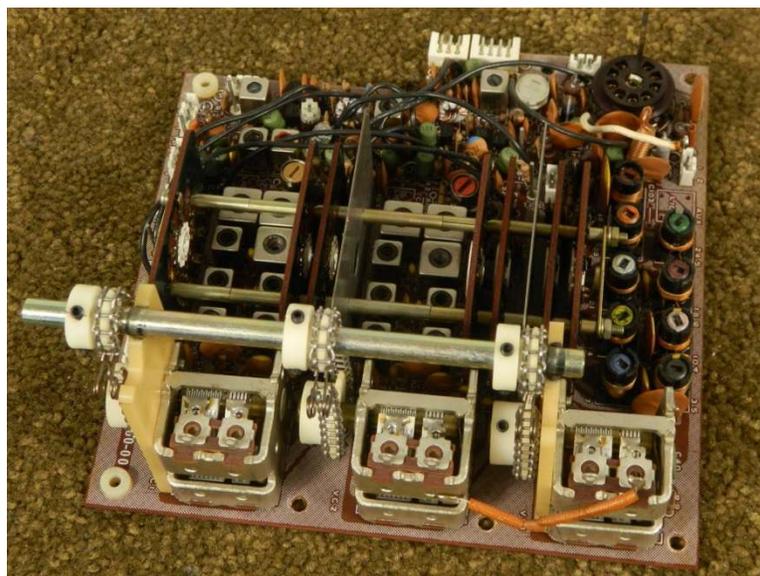
This is the RF board assembly as removed from the radio. It has only been cleaned by the use of compressed air to remove the loose dirt and dust.

Actual disassembly of the switch begins by removing the long through screws that go all the way through all seven wafers. I use a folded piece of paper to keep the switch spacers and other components in order. I use a pair of long tweezers to grab the spacers as the through screws are withdrawn.

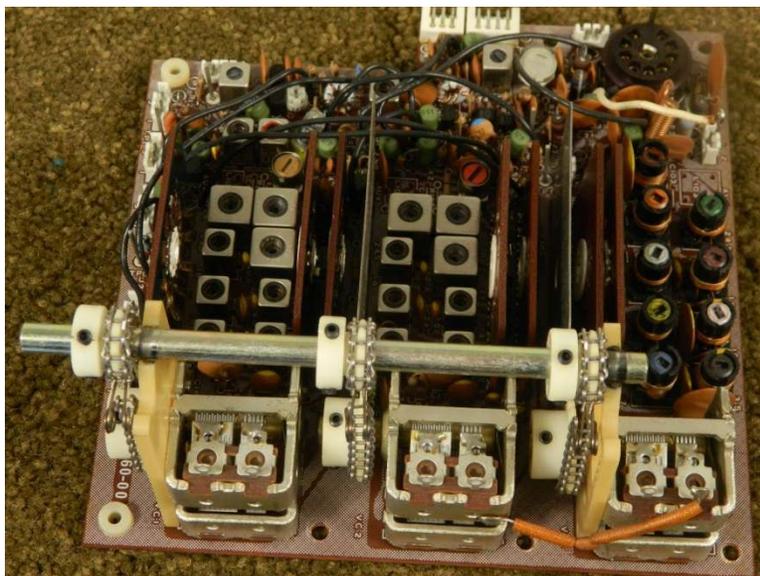
This is the same switch with the through screws and spacers removed. They are kept in order so that they may be replaced correctly.

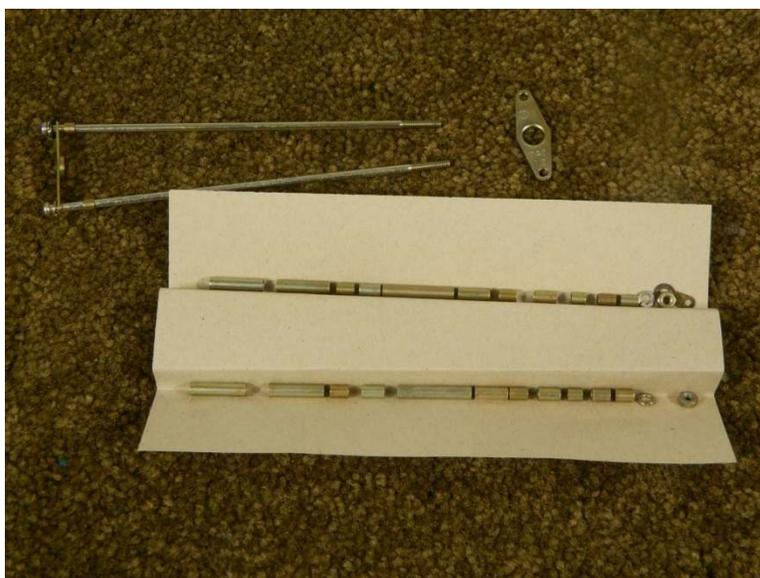
These are the through screws and spacers as removed from the switch assembly.

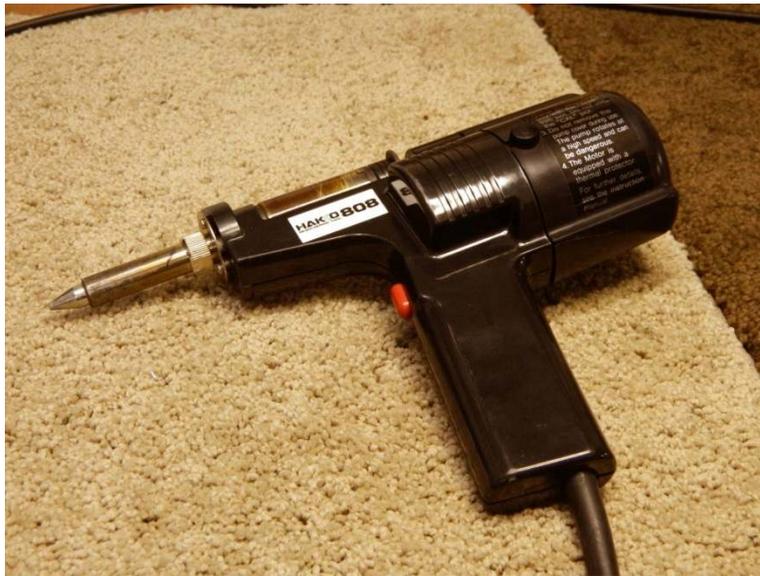
This is the Hakko 808 de-soldering tool. I have owned this one for over ten years and could not function without it. Many will think it is expensive, but it is well worth the money if you do much work on PC boards.

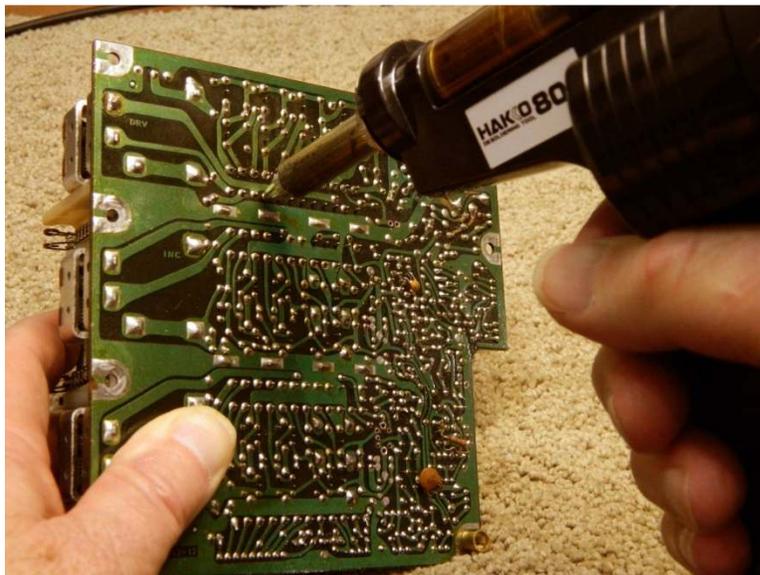
Using the Hakko 808, it is a simple matter to remove the solder around each wafer pin completely. When you have removed the solder from each pin, the wafer will fall out of the board.

You will find some of the pins have been bent down toward the board before being soldered at the factory. I use the Hakko 808 to remove as much solder from these pins as possible. Then, using the soldering iron, I heat the joint and move the wafer back and forth while the solder is cooling to prevent it from adhering to the pin. I have had good success and have lifted only a couple of traces. There is no need to re-bend these pins during the reassembly process. I wish there was a better way to do this job, but I have not found one. Kenwood did us no favors when they decided to bend these pins over.

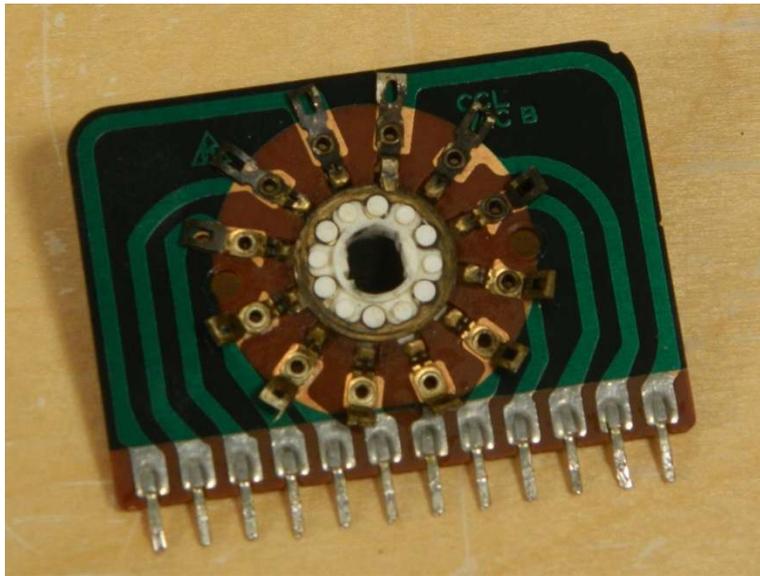
This is the first bandswitch wafer as removed from the RF board. You can see the buildup on the switch contacts and rotary contacts. This is not the worst I have seen by any means.

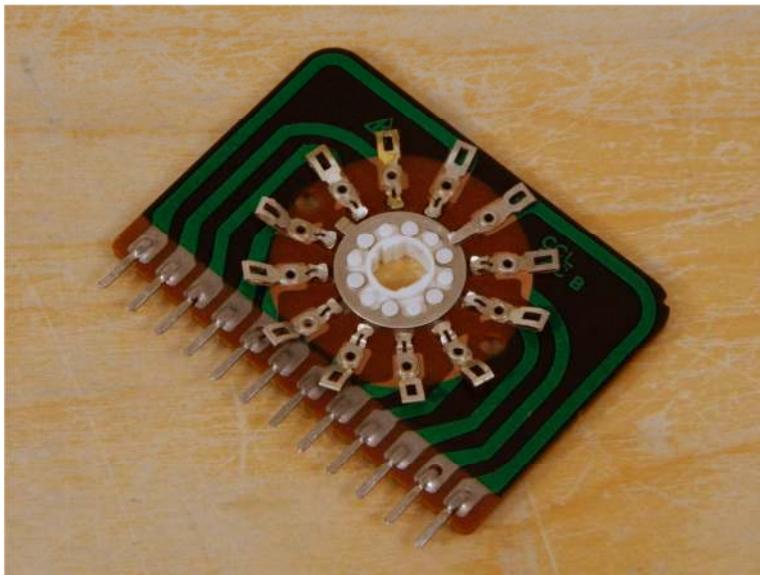
This is the same wafer after polishing to remove the tarnish on the contacts. I am now using a product made for polishing silver. It is called Wright's Silver Cream and works quite well. I use a discarded *soft* toothbrush to accomplish the cleaning/polishing and then rinse with tap water. The final rinse of the wafer is done with distilled water. The wafer is then carefully dried and blown out with canned air.

Before installing the newly cleaned switch wafer into the board, I coat the switch contacts with DeoxIT and rotate the switch contacts thoroughly. Then, dry with canned air.

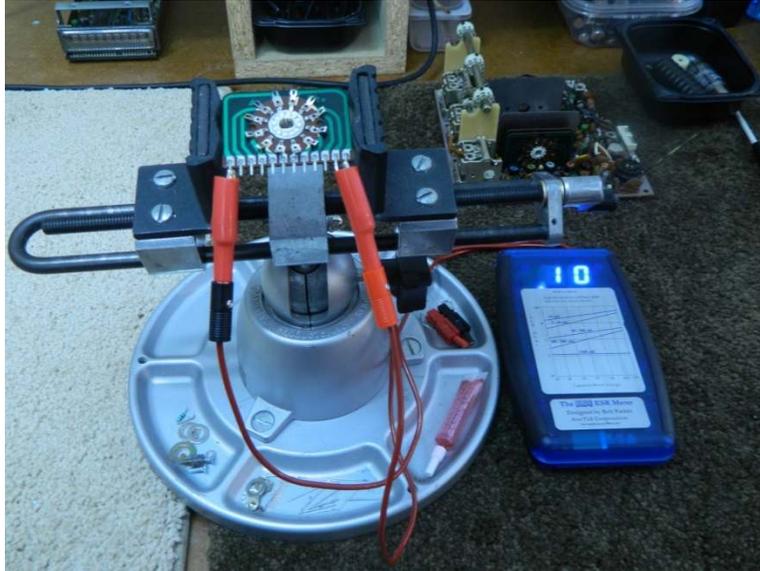
Each contact is checked for high resistance after cleaning. I am using here the Blue ESR meter which will measure quite low resistances. The reading here is .1 ohm. As you get closer to the other probe, the resistances will decrease as it is reading the resistance of the traces on the board. I also check physically for any looseness of the contact on the board. These contacts are originally held in place with rivets and they sometimes loosen.

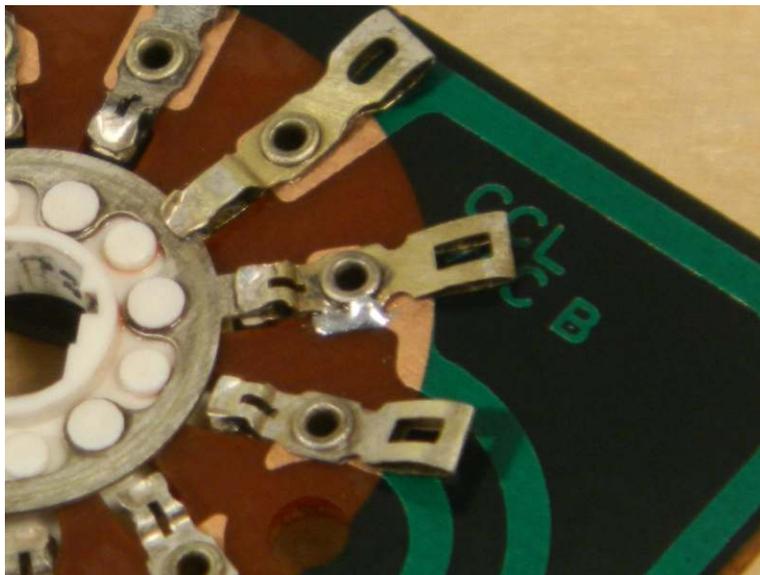
One of the contacts on this board showed a rather high resistance and the contact was found to be loose against the board. A simple way to repair this situation is to solder the contact to the board. There is usually enough of the board trace material showing to allow for soldering. I scrape the material clean with a Xacto knife prior to soldering. I then use solder that is .015 inch in diameter making it easier to control the amount of solder used and to keep heat to a minimum. I have not tried the silver solder pens for this repair.

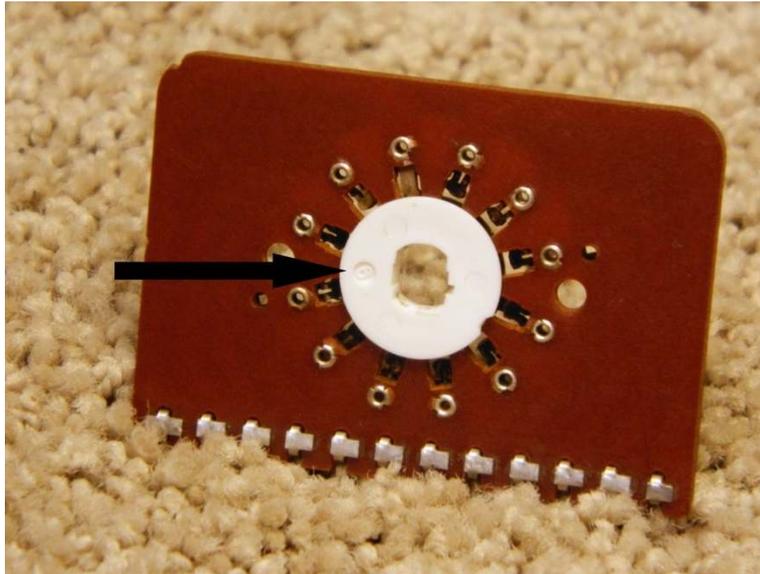
The rotary section of the switch must be properly aligned prior to installation so that each section will align properly with the switch shaft during reassembly. On the backside of the wafer are some marks that will be used for alignment. **VERY IMPORTANT!** Rotate the white collar of the switch so that the small recessed dot is at the nine o'clock position. When reassembling the switch, these will represent the 30 meter position on the bandswitch dial.

Reassembly is simply a reversal of the disassembly procedure. When inserting the bandswitch shaft, point the knob to the 30 meter position and gently push it through the aligned wafers. Tighten the set screw in the 30 meter position, then rotate the switch to the 160 meter position and tighten that set screw.
